## **2. CONTAMINATION SITE CPP-61**

### **2.1 Summary**

Site CPP-61 (PCB spill in CPP-718 Transformer Yard) is the result of a transformer oil spill containing PCBs to the soil that occurred between 1982 and 1985. Figure 2-1 shows the former CPP-718 Transformer Yard fence and Site CPP-61 during the 1985 timeframe. The current infrastructure around Site CPP-61 is shown in Figure 1-1. The Track 1 decision documentation (WINCO 1992a), approved in 1993, determined that "No Further Action" was justified for the PCB oil spill. However, because of radioactive soil identified at the site, the site was referred to the WAG 3 OU 3-13 Comprehensive RI/FS (DOE-ID 1997a) for further evaluation. The radionuclides found in the soil were determined to be below risk-based soil concentrations and, therefore, require no further action based on the baseline risk assessment (BRA) in the RI/BRA (DOE-ID 1997b). At the time of issuing the OU 3-13 ROD (DOE-ID 1999), Site CPP-61 was transferred to OU 3-14 for further evaluation based on uncertainty with regard to the extent, if any, of PCB contamination that may remain under the existing concrete transformer pad.

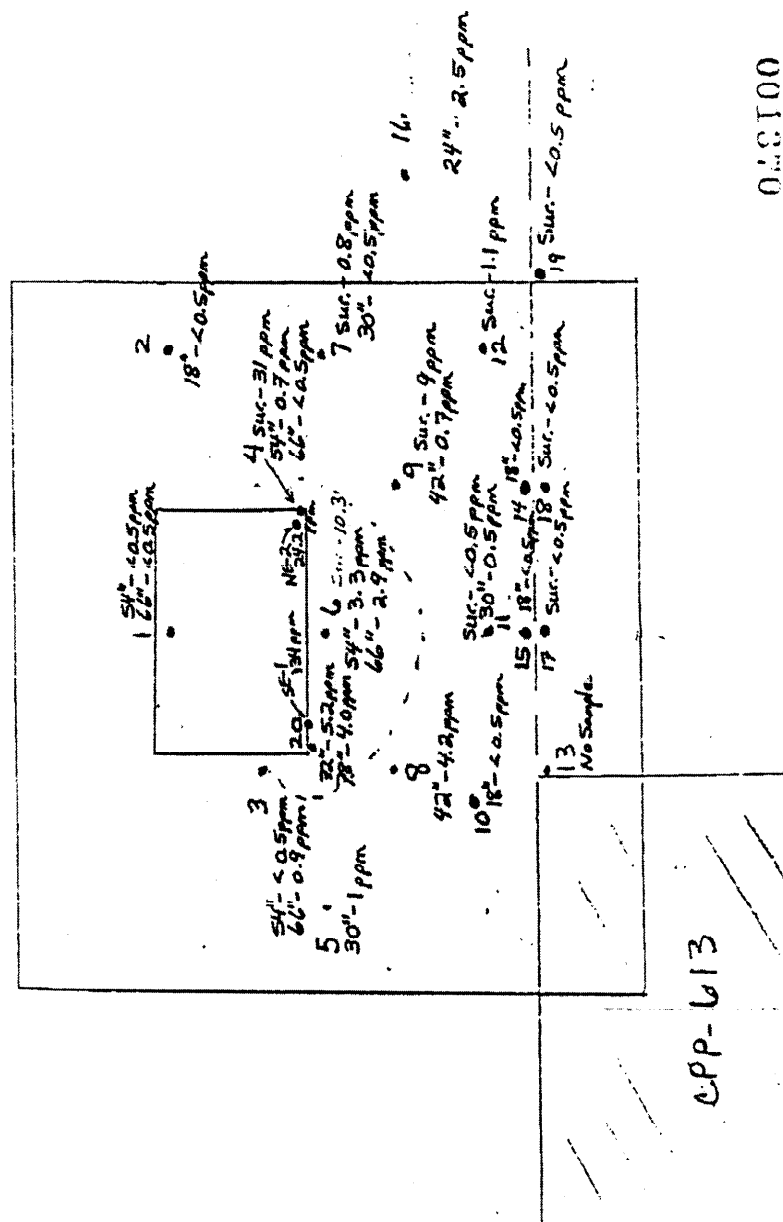
Figure 2-2. Sketch of Site CPP-61, sample locations, and analytical results prior to cleanup. (WINCO 1992a)

Site CPP-61 is the location of a 25- × 25-ft PCB-contaminated oil spill within the former CPP-718 Transformer Yard northwest of building CPP-613. The spill occurred during the UREP between the spring of 1982 and July 1985 when transformer XFR-8T2-2 operated with a 30-40% voltage overload. The overload resulted in heat expansion of the transformer oil and intermittent releases during the summer months when the transformer was maximized. Temporary measures were in place to contain the leak. These involved collecting the oil in a drip pan and then storing it in 55-gal drums. During this time period, approximately 400 gal of mineral oil with a PCB concentration of 179 ppm leaked from the transformer. The oil that was not contained contaminated the reinforced concrete pad (10 × 8 ft and 6 ft 8 in. deep) and soil adjacent to the pad, primarily on the east side (see Figure 2-2). Figure 2-2 is taken from Reference 6 in the Track 1 document (WINCO 1992a), which captured the sample locations and levels of PCB contamination. Table 2-1 presents the soil sample identification number and grid location with regard to Building CPP-613. The analytical results for PCB and sample depth in the soils, depicted in Figure 2-2, are presented in Table 2-2. Table 2-3 presents the PCB analytical results for the transformer pad.

- The sampling profile showed the pattern of PCB distribution in the soil to be restricted to the area of the immediate spill (Figure 2-2). This is documented in the Track 1 (WINCO 1992a).

- PCB-contaminated soil with a concentration greater than 10 ppm was removed and properly disposed of in the cleanup. The soil used as backfill at the site contained  $\leq 10$  ppm PCB. There is no empirical evidence to support concerns that PCB concentrations below the current pad would exceed the concentrations allowed for backfill soil (i.e.,  $\leq 10$  ppm). Next to the southeast corner of the pad where the deepest sample was taken, sampling location #20 (Figure 2-2 and Table 2-2) contained 5.2 ppm PCB at the 72-in. depth and 4 ppm PCB at the 78-in. depth.

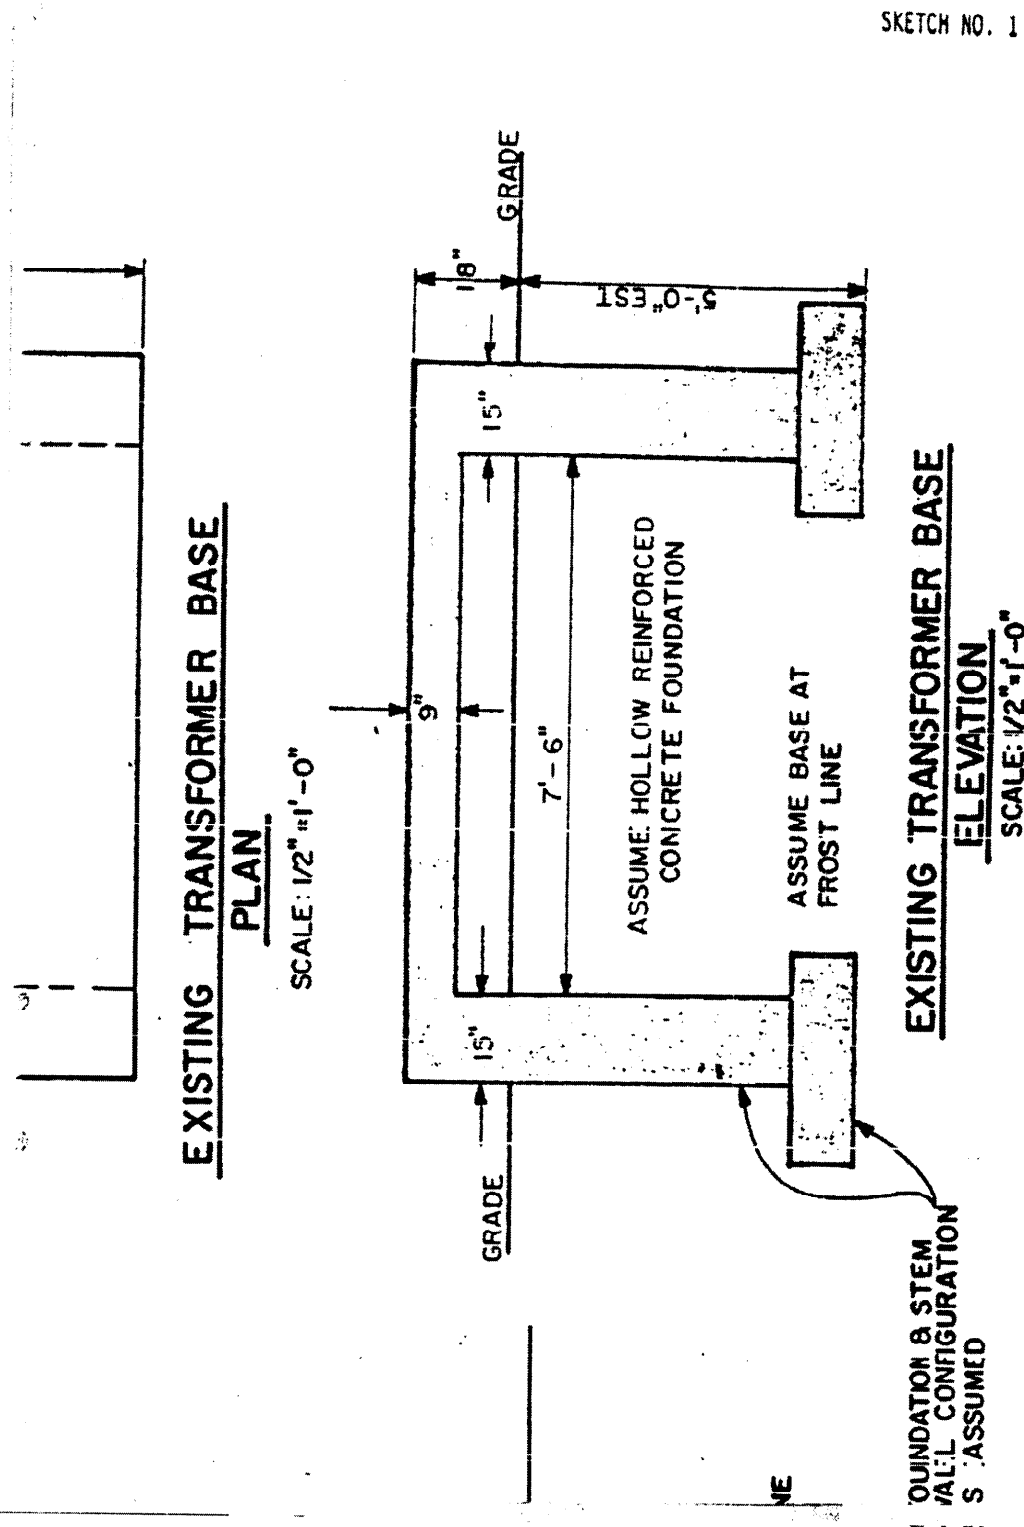
Figure 2-3. Original transformer pad XRF-8T2-2, removed in July 1985.

The 10- × 8-ft transformer pad was constructed of reinforced concrete. It was 9 in. thick and supported 9 in. abovegrade. The foundation was 5 ft below grade and the stem walls were 15 in. wide for a 7.5- × 8-ft area under the concrete pad (see Figure 2-3).

Where the original concrete pad's configuration was that of a hollow concrete foundation (Figure 2-3), any contaminated soils below the pad would be accessible during the excavation. Figure 2-4 shows the XFR-8T2-2 transformer location, site of the original concrete pad that was removed. The grounding grid for CPP-718 and CPP-613 is also shown. The "Daily Construction Log" for the UREP SS Phase II project dated July 25, 1985, clearly states that the contractor M-K could not lift the pad (the old pad) due to soil between the foundation walls. They removed a section of the east fence (fence around CPP-718 Transformer Yard) so dirt between the foundation walls could be removed with a backhoe. After the dirt was removed, the pad was lifted onto a truck (see Appendix C). Removal of the concrete transformer pad is discussed as being removed from the "hole." This "hole" would have been created by the removal of the contaminated soil around the pad and any under the pad, see Appendix C, Daily Construction Log, dated July 29, 1985. Pictures of the pad being removed are found in Reference 10 of WINCO (1992a).

- Remove and dispose of the concrete transformer pad (concrete and rebar) that transformer XFR-8T2-2 was sitting on
- Remove PCB-contaminated gravel and dirt in the yard in the vicinity of the XFR-8T2-2 pad
- Provide PCB sampling and analysis for the transformer, the oil removed from the transformer, transformer accessories, and gravel and dirt in the yard area in the vicinity of the XFR-8T2-2 pad.

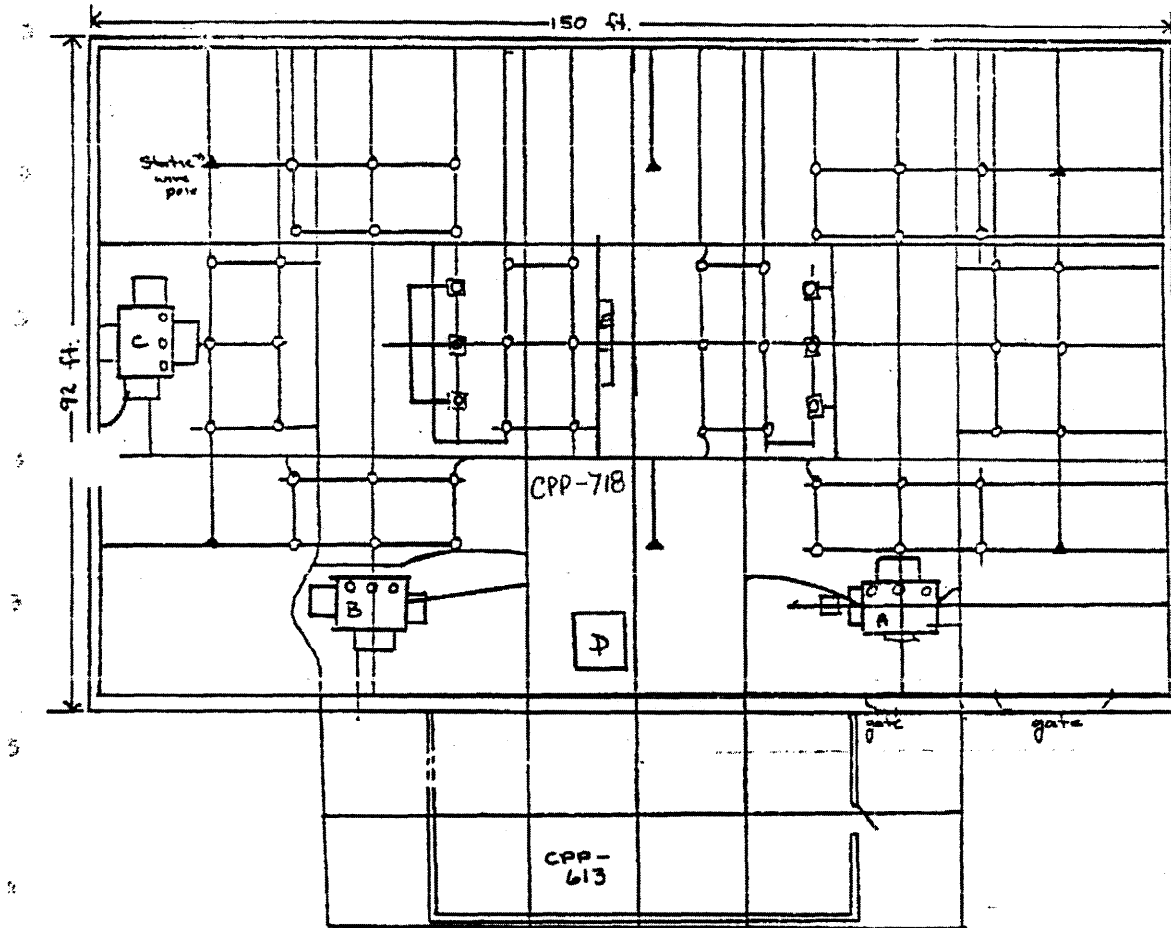
Figure 2-4. Location of XFR-8T2-2 and grounding grid with respect to CPP-718 and CPP-613.

- A: Transformer XFR-8T2-2 disconnected and removed during 7/00
- B: Existing transformer XFR-8T2-3
- C: Existing relocated transformer XFR-8T2-1
- D: Manhole
- E: Outdoor circuit breaker
